NTSB Raps Some Knuckles With Boeing Battery-Fire Report

By Mark Anderson
Posted 22 Dec 2014 | 18:26 GMT

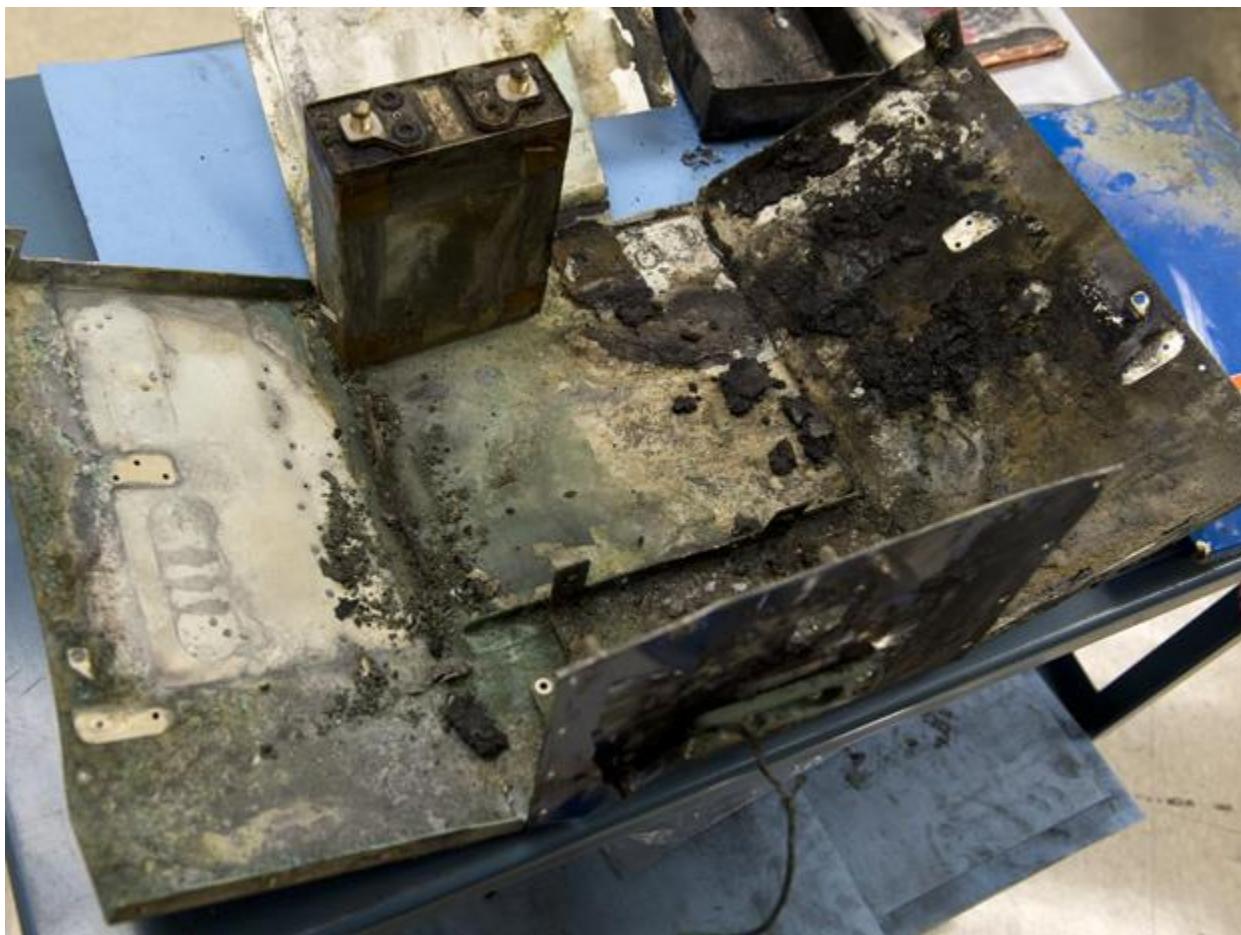
Photo: Saul Loeb/AFP/Getty Images The burned-out battery case from a Japan Airlines Boeing 787.

However, NTSB has concluded the battery caught fire because of an internal short circuit, possibly arising from either a manufacturing defect in the cell or from temperature spikes allowed by a poorly designed battery management system.

For instance, he says, battery manufacturer GS Yuasa wasn't sufficiently careful in keeping welding debris and other metal filings out of the battery cells. Moreover, cell assembly involved winding battery materials around a cylindrical mandrel and then flattening the cells by hand into a squashed oval shape that was then compacted into the battery container.
